The Story of the 2011 Structural Restoration of Pratt Hall's Gothic Tower.

The 2011 Tower Project : Every Project Tells A Story:

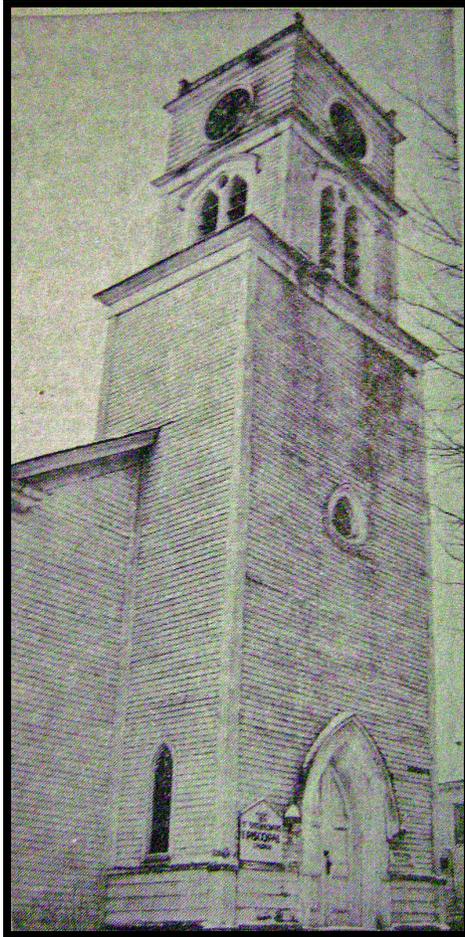
St. Bart's 1974. Note evidence of water damage at the top of the first section of the tower. Also the crenellation had been replaced by a railing type design some time after 1934.

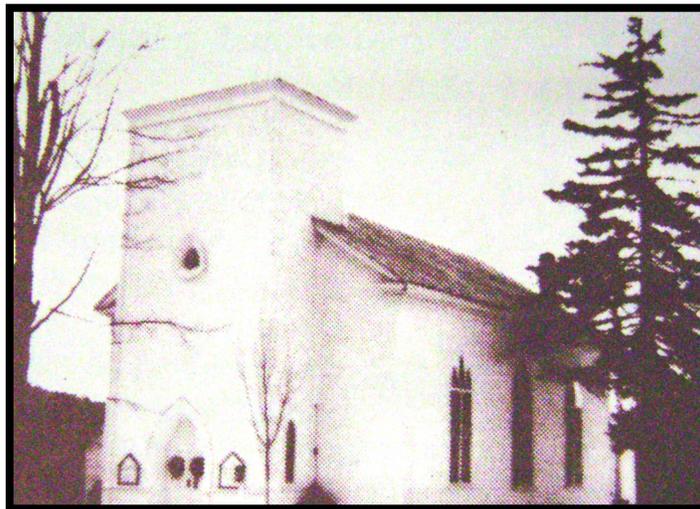
Pratt Hall in 1974 after the top two sections of the tower, clock, and bell were removed. Note condition of the roof.

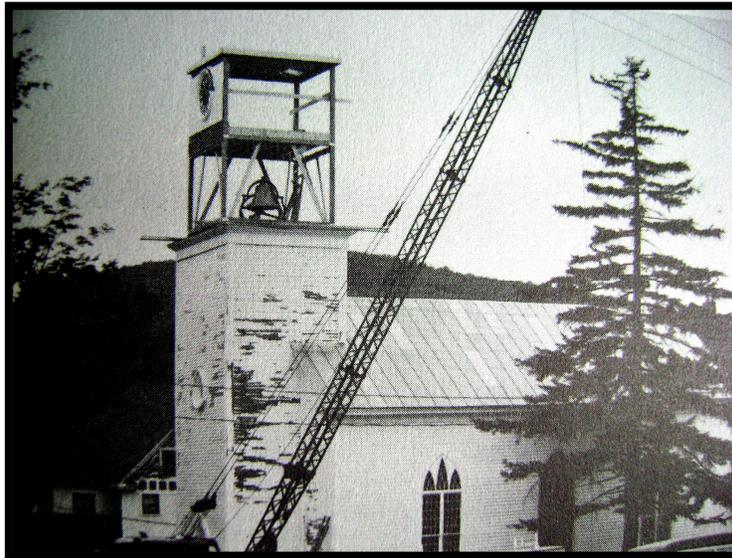
1985 reconstruction of top two sections of the tower.
One clock face and the bell have been set in place. Also note new standing seam roof.

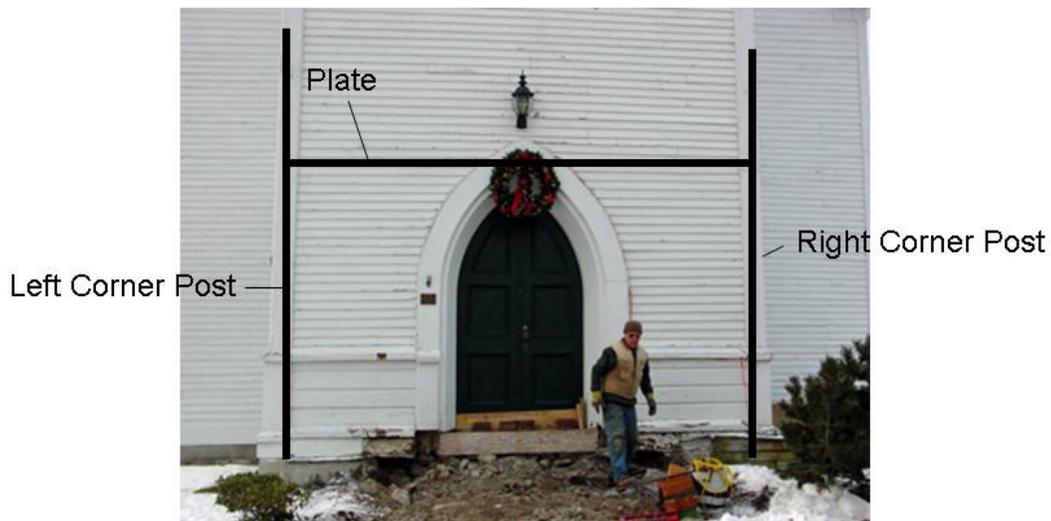
1.

Demolition revealed the original front wall framing was probably for a conventional rectangular door. The pointed "gothic" door was added later but they had to cut out a center section of the plate above the door to allow for the point of the arch. This compromised the structural integrity of the middle part of the front wall. There was extensive rot and insect damage to the right corner post.

This photo shows the approximate location of these timbers and the completed demolition of the front steps.

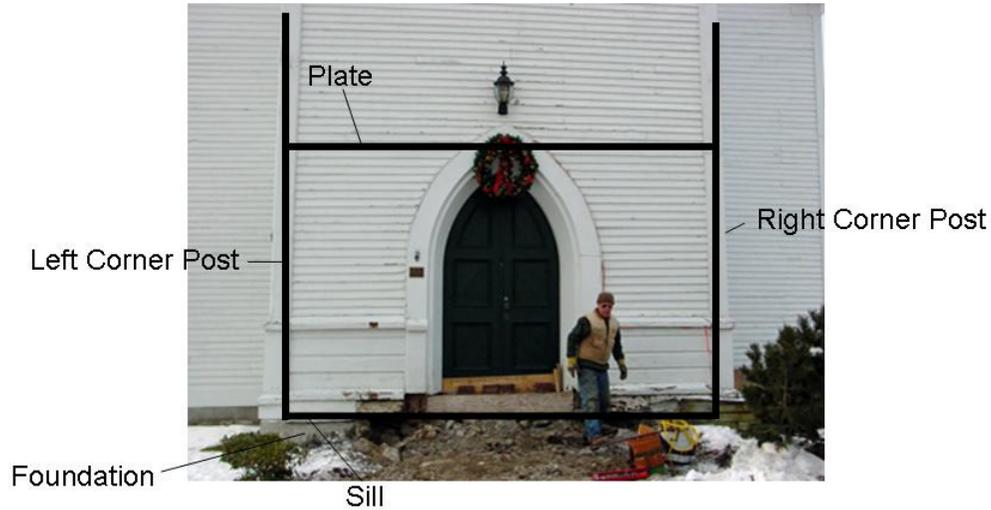
2.

Demolition also revealed the front steps had been modified and enlarged at least three times. During repairs in the eighties a new concrete foundation was poured around the entire base of the tower except under the door because the steps were in the way. The front sill was completely rotten, as were a good portion of the floor joists and post/stud bases.

Work will include a new 10 X 10 post, sill, and plate: joists; and wall studs/posts. The foundation under the door will be rebuilt too. Everything will be buttoned up with matching siding, trim, moldings, and other details.

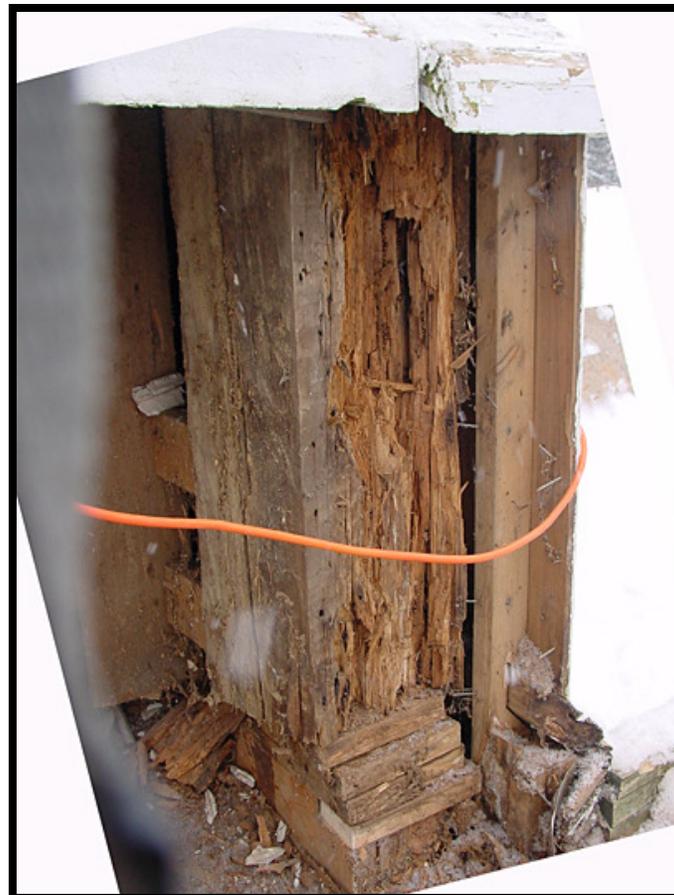
3.

Extensive rot at bottom, of the front right post.

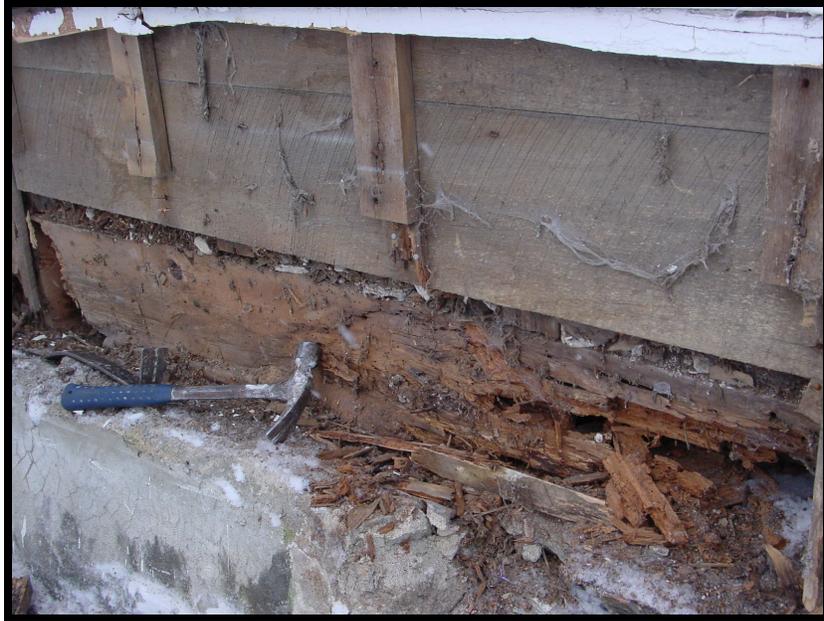
4.

Exterior of front sill to the left of the door. Central portion of sill had disintegrated. Right portion of sill was identical to the above.

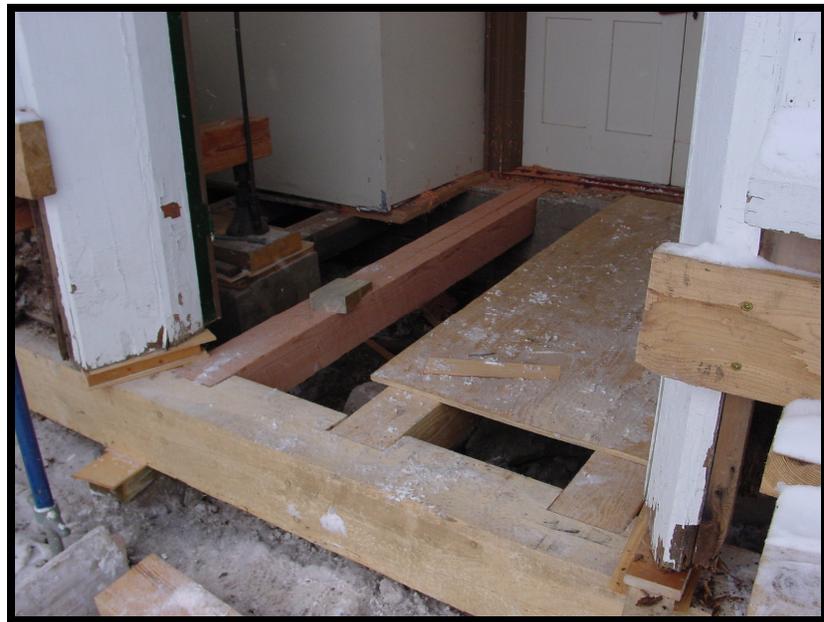
5.

New 10 X 10 sill spans the entire width of the tower. New floor joists in the entryway.

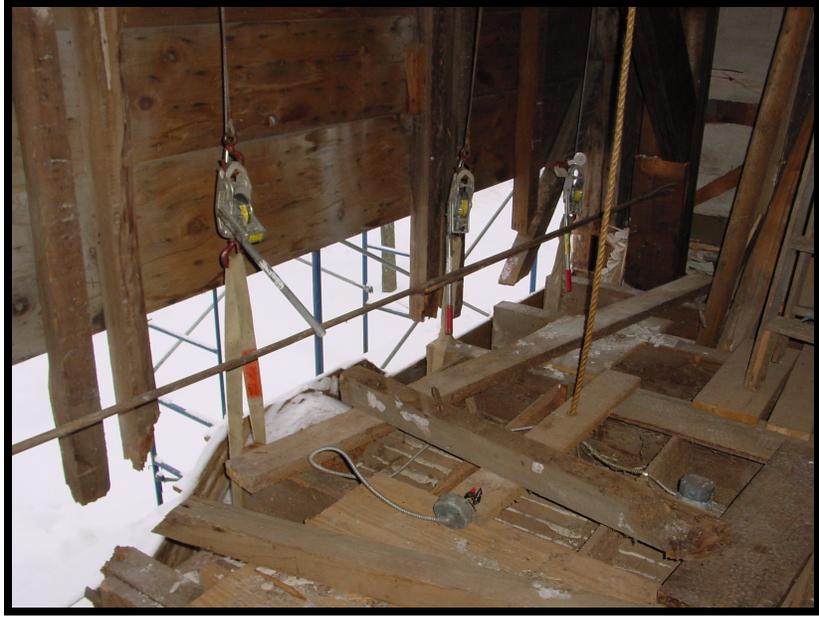
6.

Void where the remains of the old plate/girt above the door were removed. Joists/rafters suspended by cables. Posts/studs and bracing held in place only by sheathing.

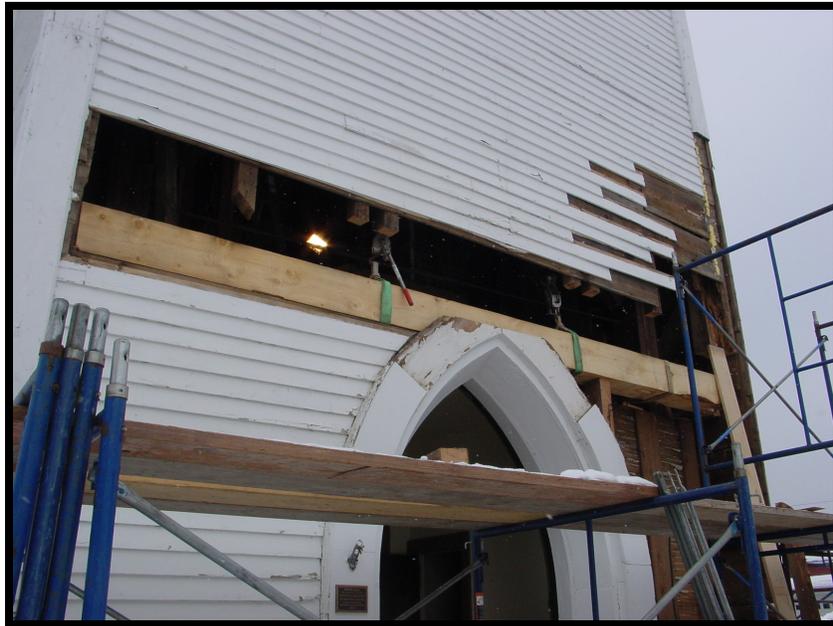
7.

New plate hoisted in place.

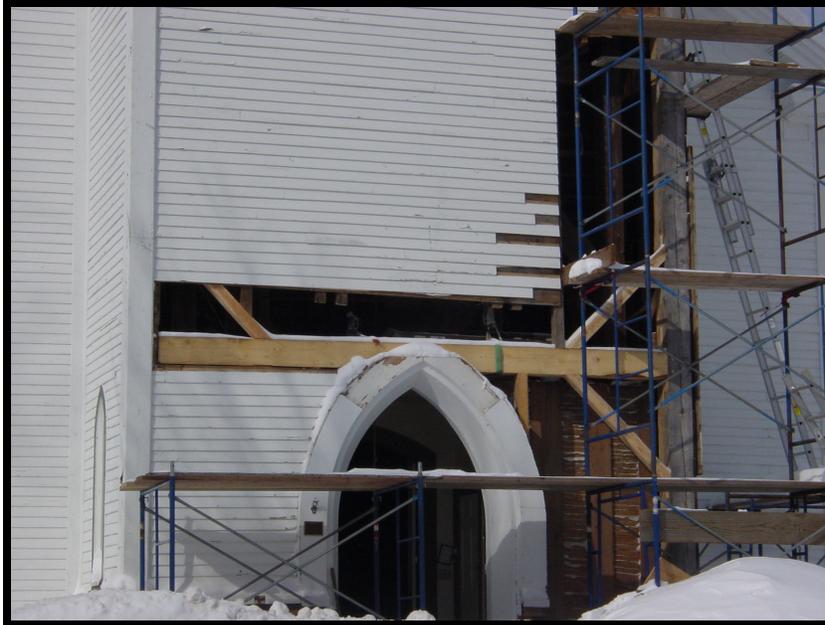
8.

New plate with braces attached to new right front corner post.
New vertical studs/post would be sistered to existing.

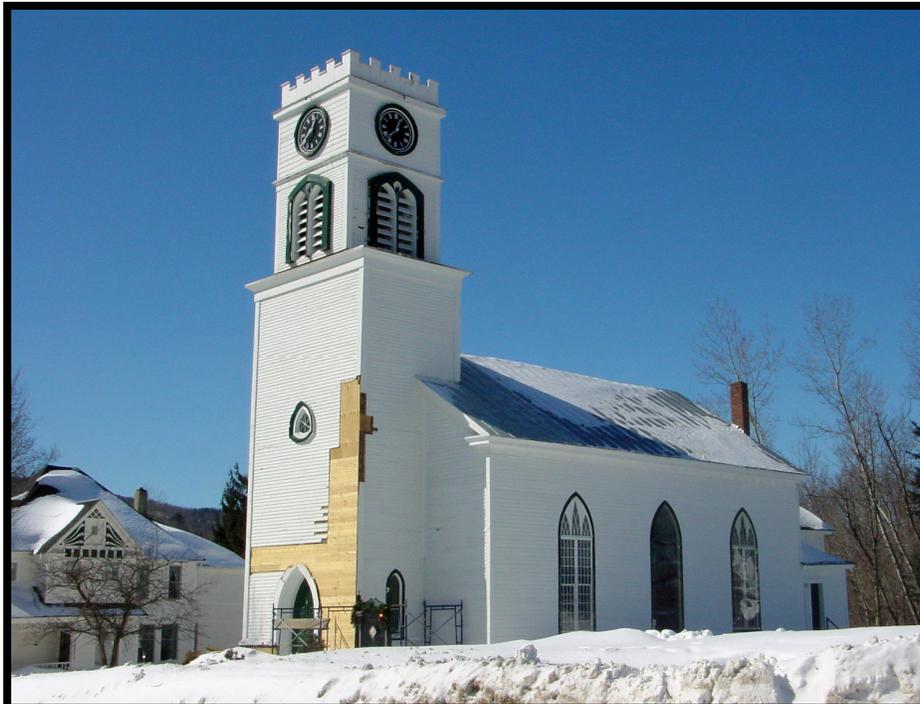
9.

Late March 2011. New sheathing installed after urgent structural repairs (above) were completed. Additional joinery completed inside shortly thereafter.

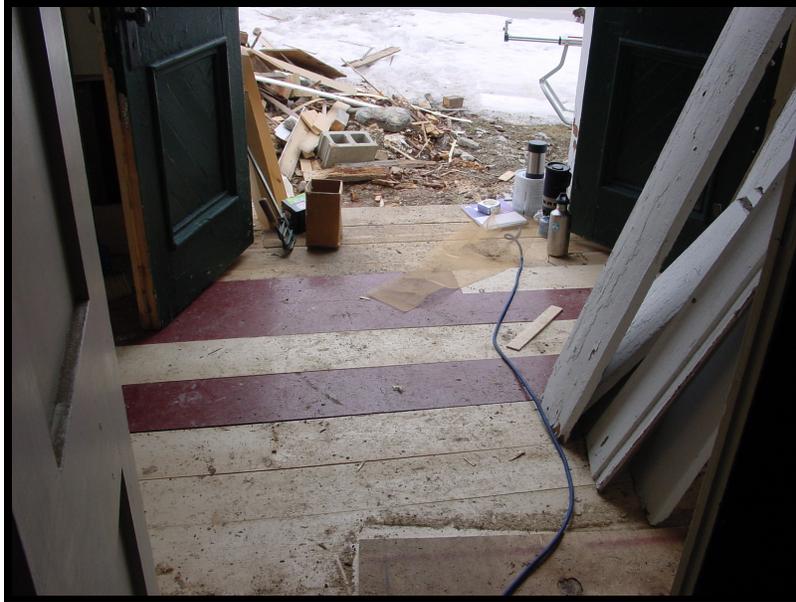
10.

New floor. Red Boards are from original floor.

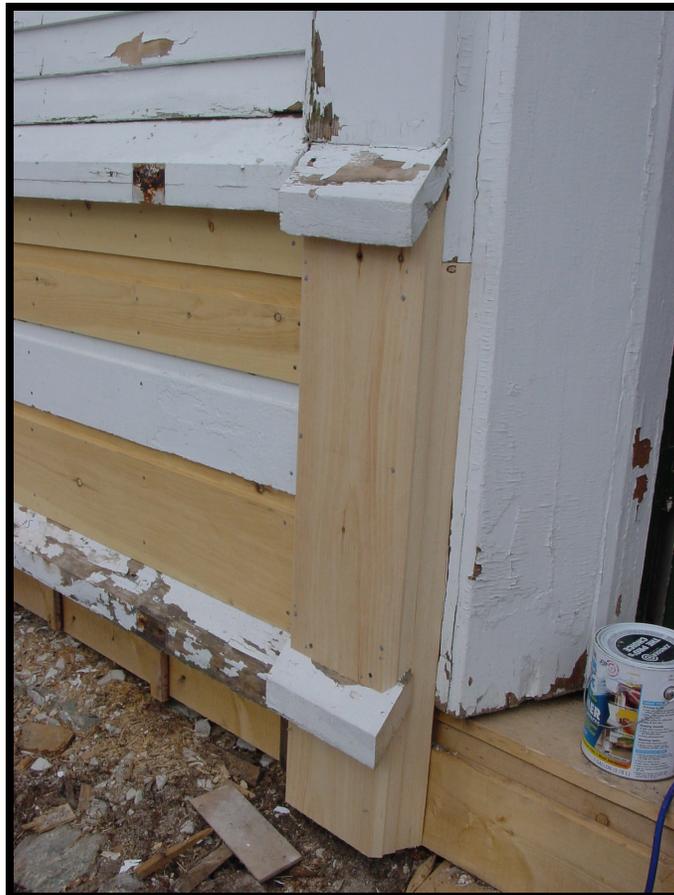
11.

New siding and trim detail.

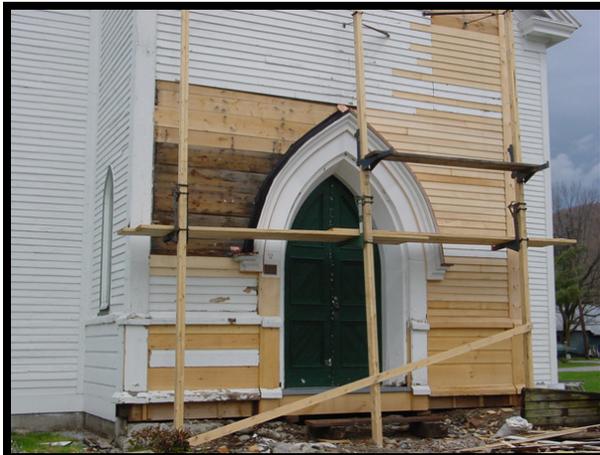
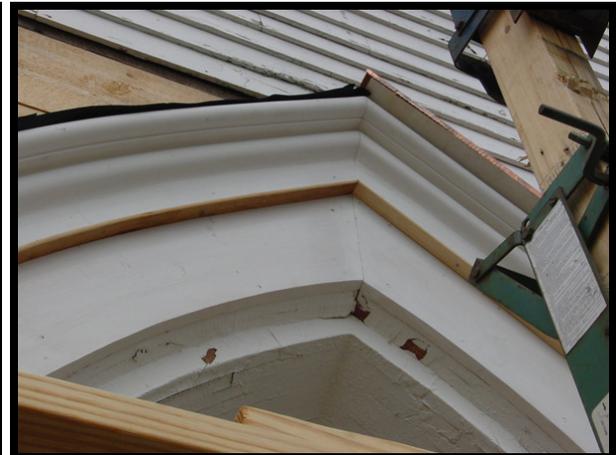
April 28, 2011. Note new replica door hood molding.

During the final phase replica gothic moldings were returned above the door and around the small triangular window approximating the likely appearance after renovations in the 1870s.
